January 2009  
Newsletter

## Infrared Energy Audit

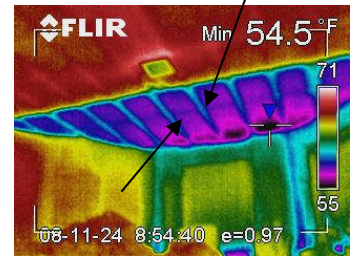
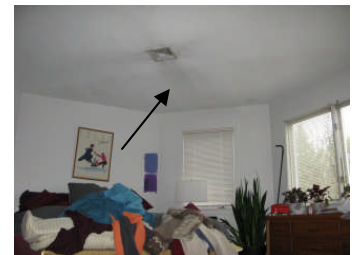
### Newton, MA

This family lived in this home for 18 years without knowing that 1/3 of the master bedroom ceiling had no insulation at all. **The cost of this energy audit paid off BIG!**

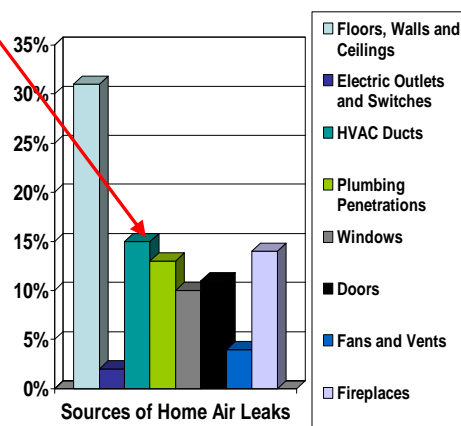
## Source of Home Air Leaks

1. Stack effect heat loss from missing caulking and sealing at plumbing and electric cut outs, and holes or gaps around the chimney.
2. Fiberglass insulation installed improperly and thus unable to provide a proper air barrier.
3. Leaky HVAC duct system and air handler installed outside the building envelop (attic, crawl-space and garages).
4. Recessed lights with improper air sealing.
5. Rim joist and basement sill not caulked, sealed and insulated properly.

We recommend to all our customers to replace and fiberglass insulation at the basement sill with closed cell spray foam insulation. This provides air sealing and insulation in one product.
